An identity crisis: Hawker Sea Fury FB11 VX730

Abstract: *This paper looks at the role of original paint and other fabric in discovering the identity and history of the Memorial's Hawker Sea Fury aircraft.*

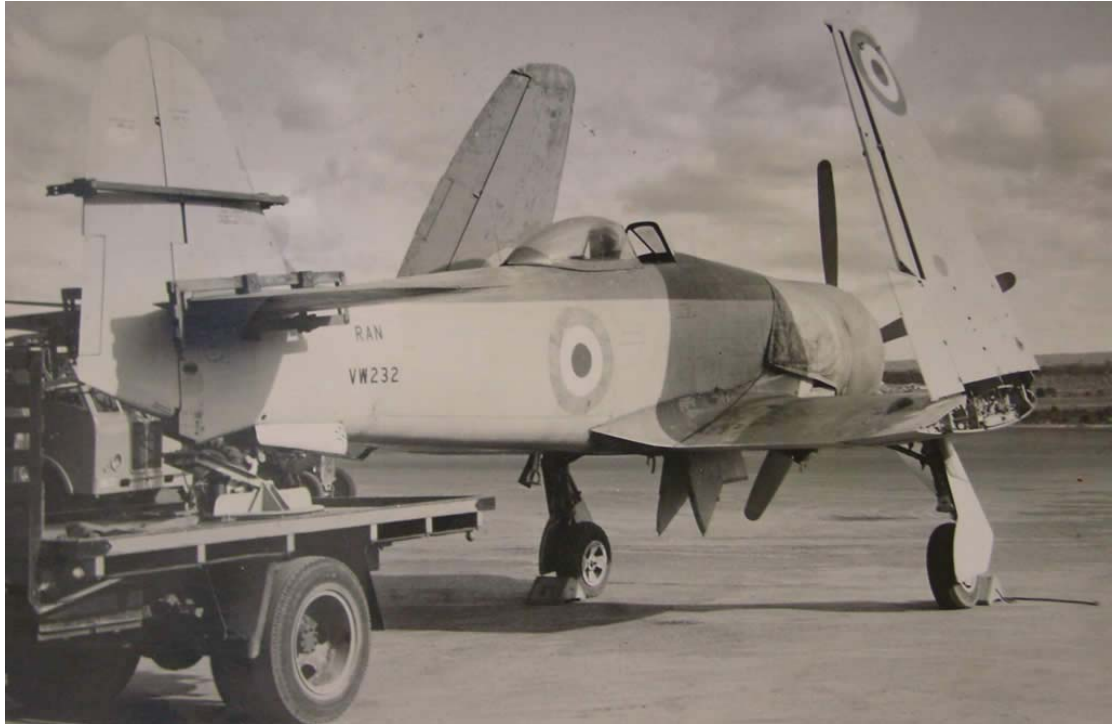
Figure 2. Sea Fury VW232, 8th July 1953.

VW232 was taken on charge in 1944 and designated as a training aid in 1951 after taking four cannon shells from an enthusiastic but errant wingman. It was then reduced to spares in 1953.

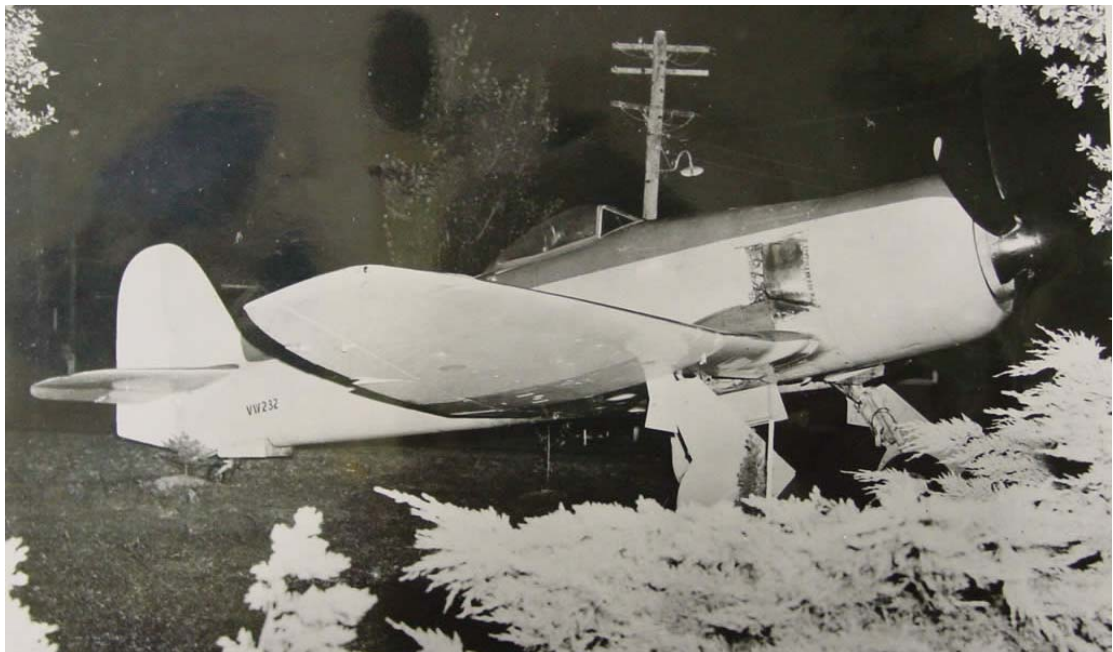
Figure 3. Gate guardian at Nowra (note dent in wing).

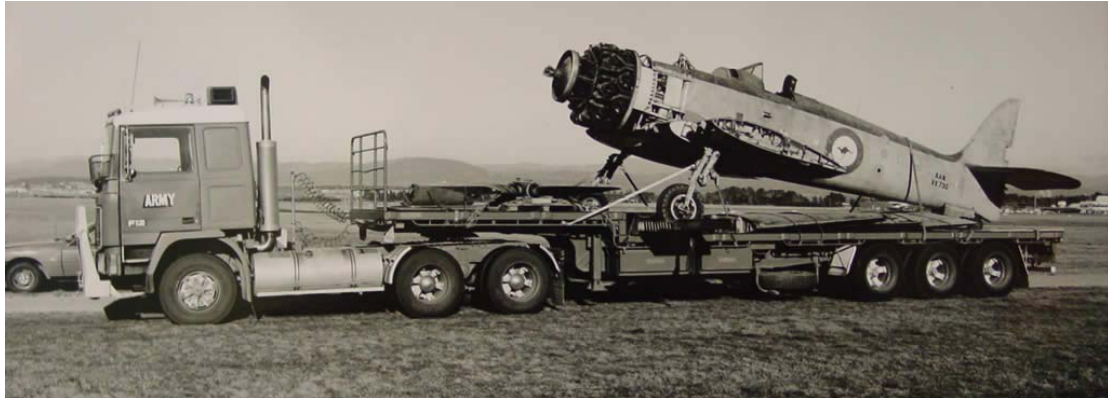
Figure 4. Sea Fury VX730 on truck

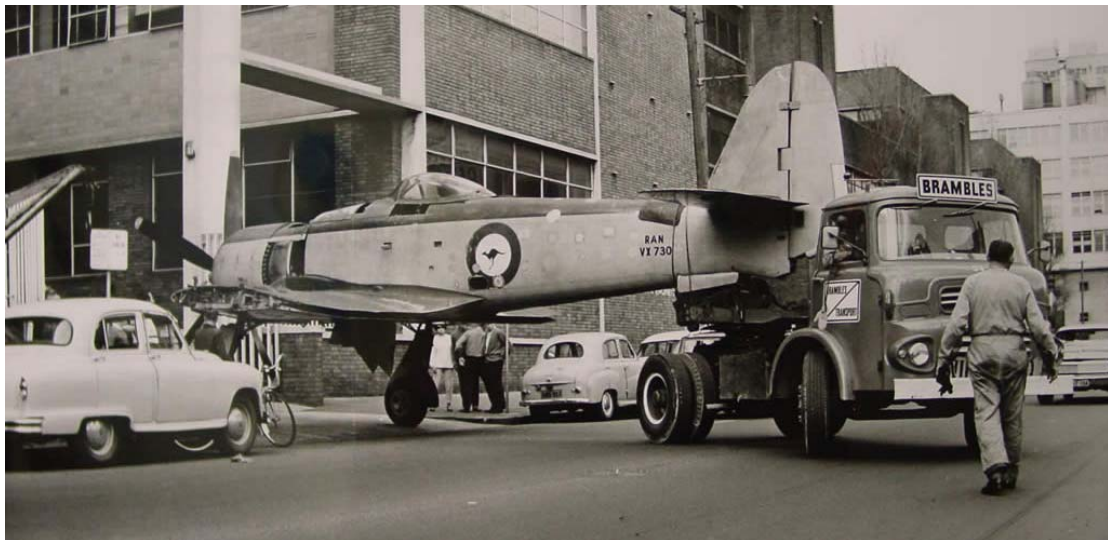
Figure 5. Sea Fury VX730 at Sydney Technical College.

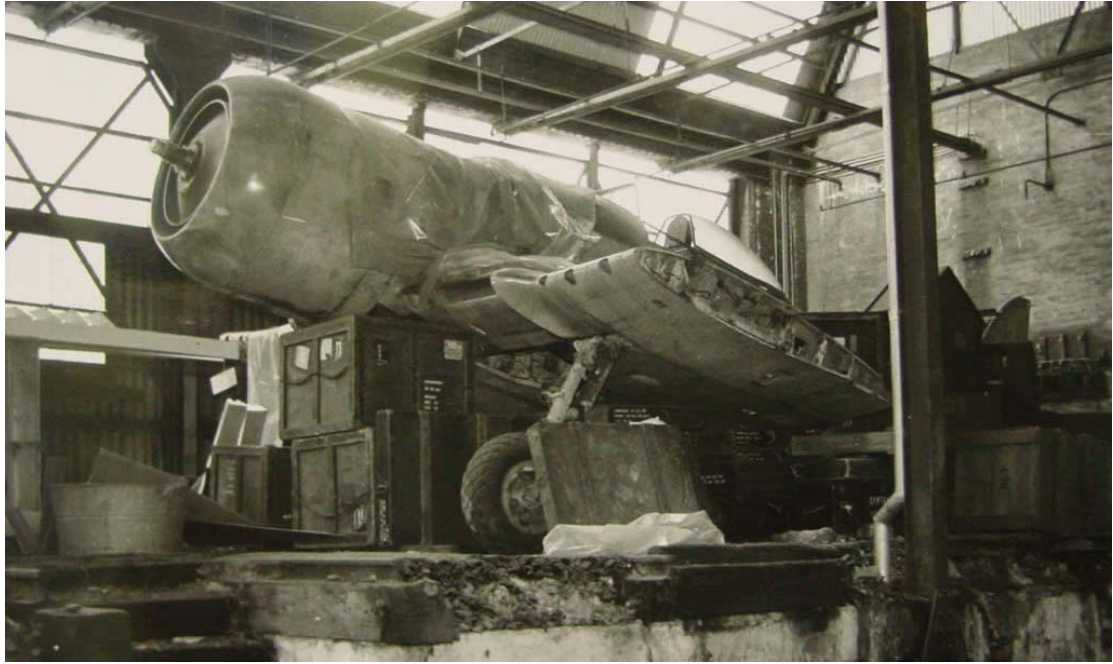
Figure 6. VX730 in less than ideal storage.

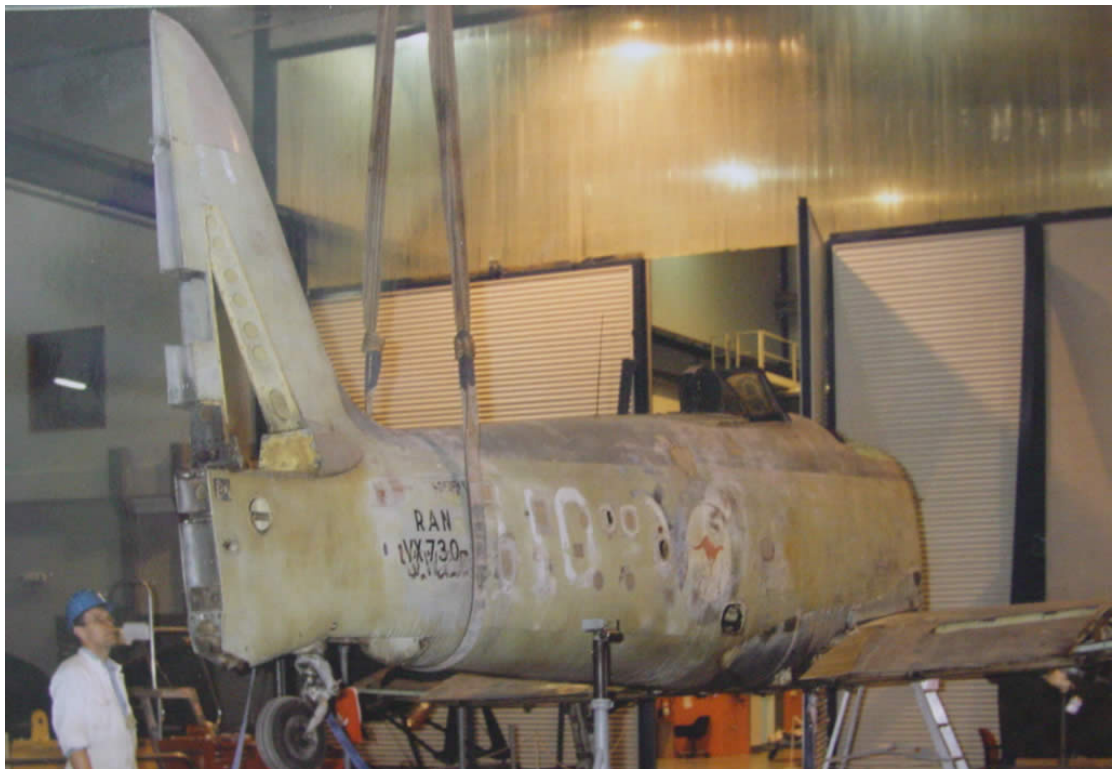
Figure 7. VX730 in the workshop.

The aircraft initially was in a sad condition, reflecting a very chequered past. It was structurally sound though, with minimal corrosion. The major assembly, comprising the engine, fuselage and wing centre sections, was dirty and damaged. Many minor components and panels were missing. Twenty-one pallets of loose components and the two outer wing panels were on hand following the parts audit and subsequent scavenging from WG630, and it was anticipated that a reasonably complete and accurately presented aircraft would result from the treatment.

As a result of this audit, Sea Fury VX730 was chosen for treatment in the Memorial's Treloar large technology conservation workshop and subsequent display in Aircraft Hall, with WG630 acting as a source of the spares required for completing VX 730.

Before any work was commenced, accurate tracings of all markings and stencils were taken. The aircraft was then completely dismantled into major components and thoroughly cleaned. Mechanical damage was repaired where either aesthetics or

safety required it. Non service handling damage was repaired either mechanically, or with standard automotive filling procedures where repair would unacceptably disrupt original material.

Similarly, missing components were replicated for visual or structural integrity. Such parts were suitably identified as replicas by stamping 'AWM 99' into them. No paint stripping was performed. Painted surfaces were solvent cleaned to remove a 'protective' varnish and then progressively evaluated. Preparation was limited to a light rubbing back to remove loose paint flakes, to provide a key for inpainting or to minimise colour variations due to weathering.

Most of the undersurface paint layer, other than the outer wing panels, was retained, with inpainting of damaged or weathered areas as necessary to achieve an integrated appearance.

Most of the top surfaces were lightly repainted as these were badly weathered or worn through by foot traffic. Colours were matched to traces actually found on the aircraft. Roundels and stencils were reapplied using either tracings of the originals, or photographic and printed references.

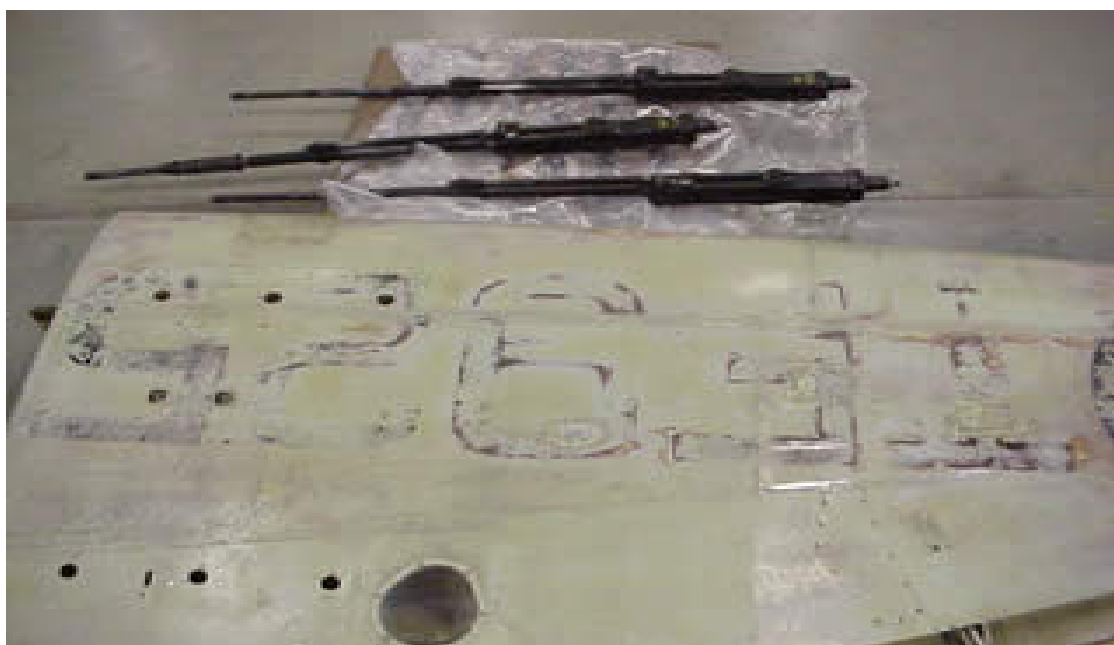
Figure 8. Port wing undersurface (note Hispano cannon).

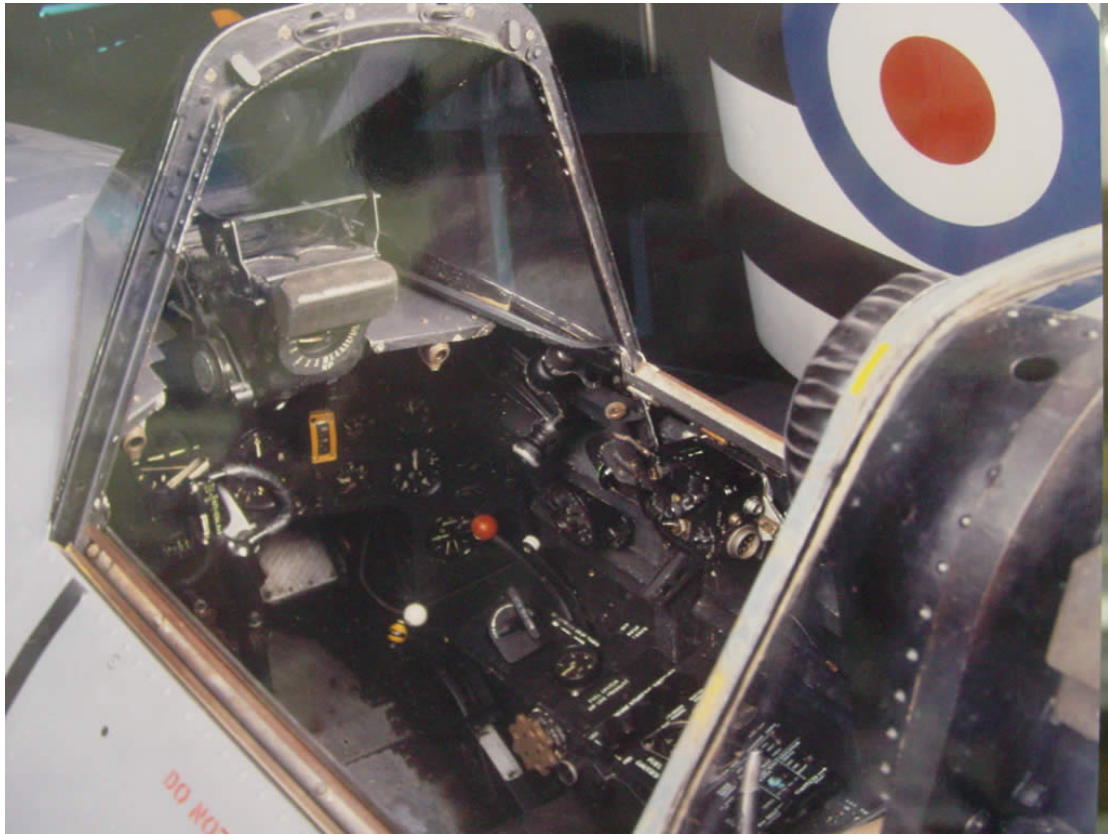
Particular care and detail went into the location and fitout of the cockpit instrumentation and controls as many of these were either badly weathered or missing. Curatorial acquisition and preparation of the necessary instrumentation had preceded the project for many years. Original instrument and cockpit surfaces were retained, with inpainting of missing paint areas as required. Four Hispano 20mm cannon previously shown, obtained via the police gun amnesty buyback scheme, were cleaned and stabilised and fitted to the aircraft.

Figure 10. Cockpit internals.

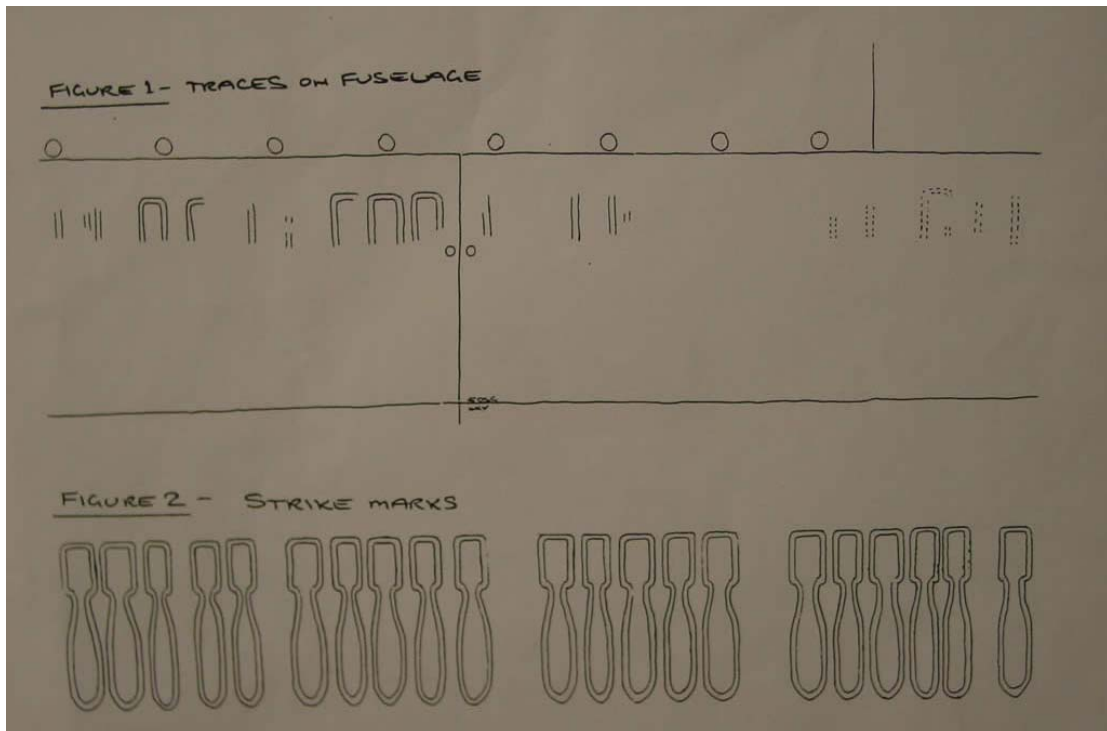
It was at this stage, eleven months into the project, that the necessity to preserve as much original material as is possible on historic objects was reinforced. Oblique lighting (provided by sunlight conveniently streaming through an opened large sliding workshop door) on the recoated surface of the fuselage, revealed very faint traces of at least twenty-one mission markings that were not originally visible, but showed up after the repaint as a slight thickening of the underlying paint.

Figure 11. Mission marking traces located on side of aircraft.

These traces were too faint to photograph clearly, but here is a sketch of the markings.

All markings specific to VX730, based on original photographs, were applied to the aircraft in an easily reversible medium, so that they could be removed should future evidence or research reveal more of the true service history of Sea Fury TF925/VW232.

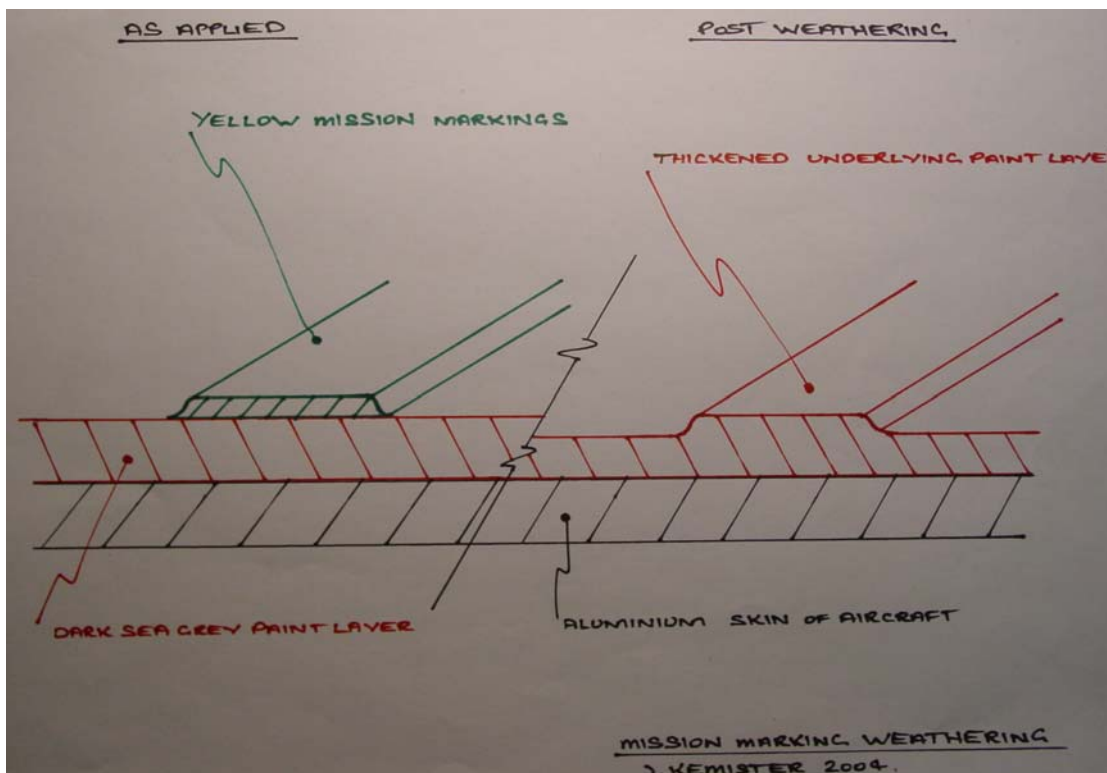
Figure 12. Weathering process.

This evidence, combined with possible battle damage at four locations, was a strong indication that the cockpit section performed active service in some theatre, even though no records confirmed this for either TF925 or VW232. The markings

correspond exactly (in size, layout and groups of five), with those on actual photographs of other active service Sea Fury aircraft.

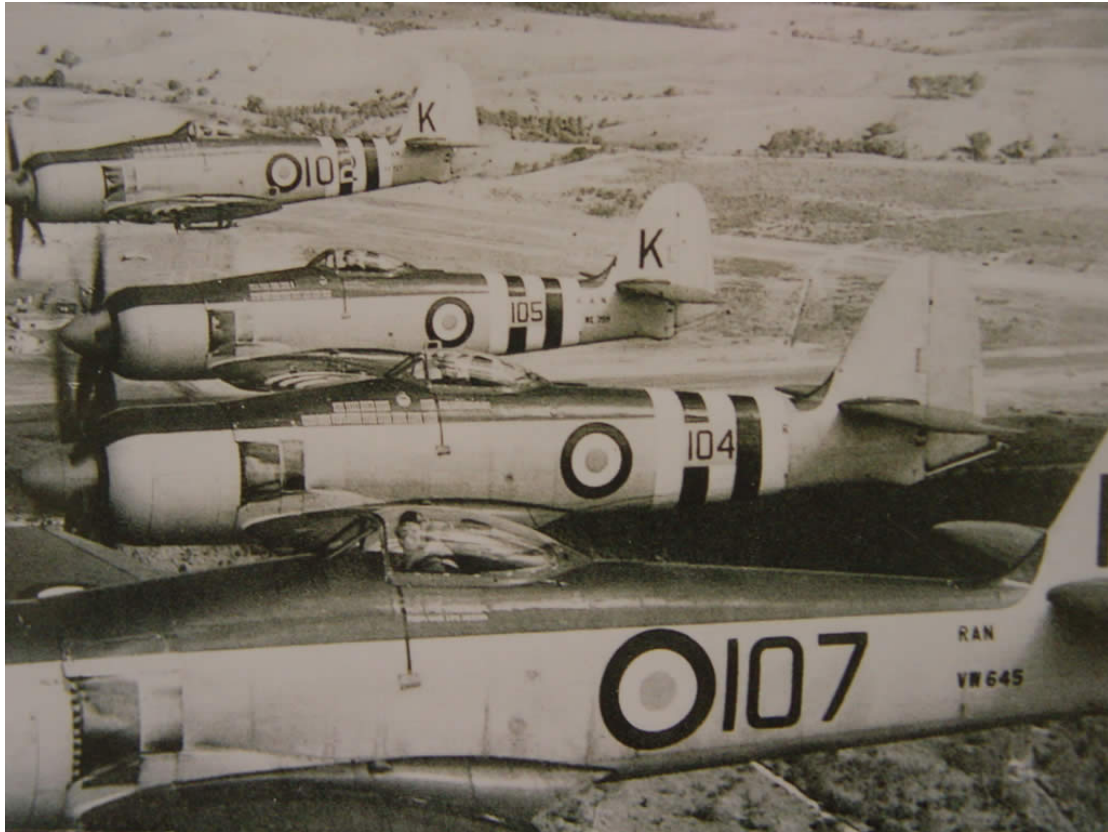
Figure 13. Sea Fury group showing mission markings.

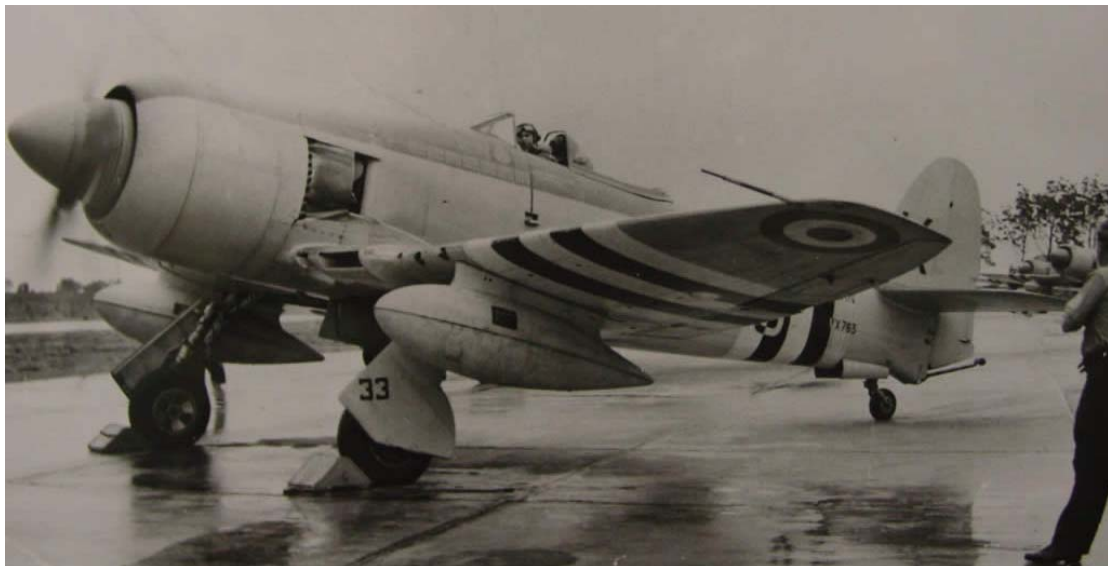
Figure 14. Markings on VX763.

It was initially believed that these markings were bomb tails, but subsequent discussion with pilots indicate that the markings shown are the tails of rockets, with the lower body and head obliterated by weathering.

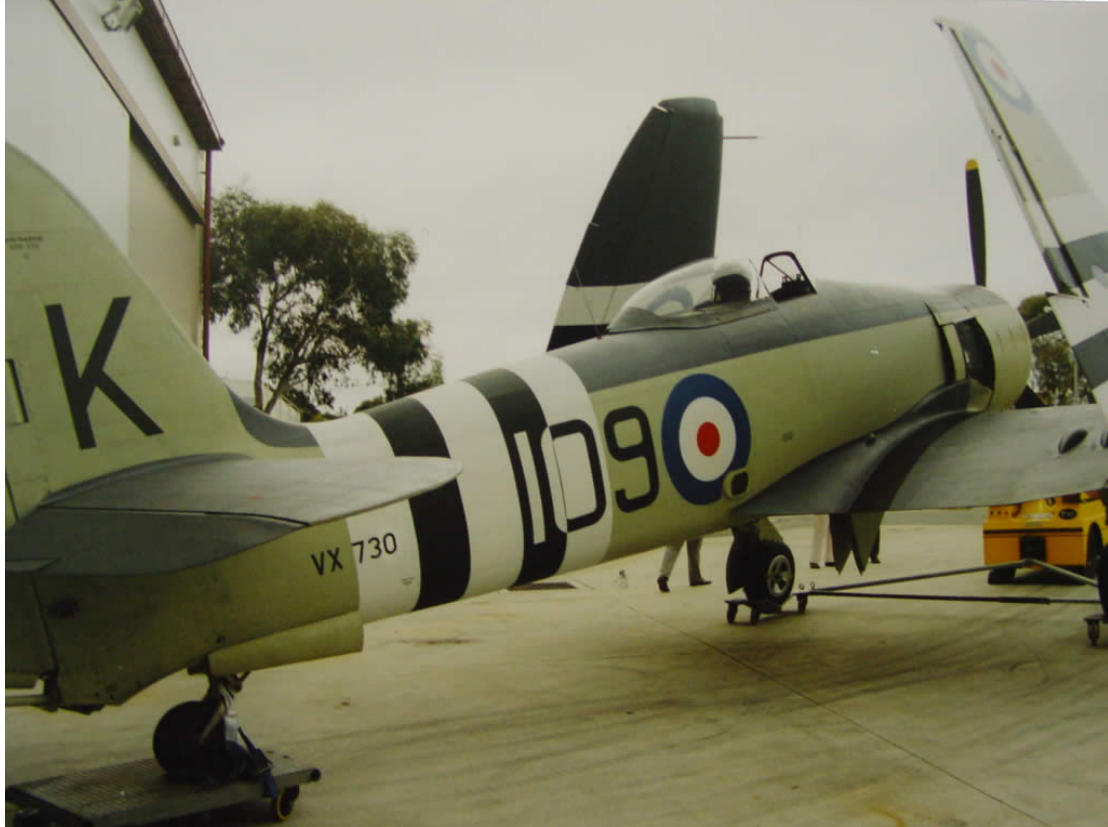
Figure 19. Completed aircraft at rollout.
